## Perfect Retrofits, Burlington, ON

A trio of buildings developed a problem with another brand of IG Unit. They were breaking down and not delivering the increased R-Values promised. ECO Insulating Glass is tasked with replacing the failed IG Units over a scheduled period of time.

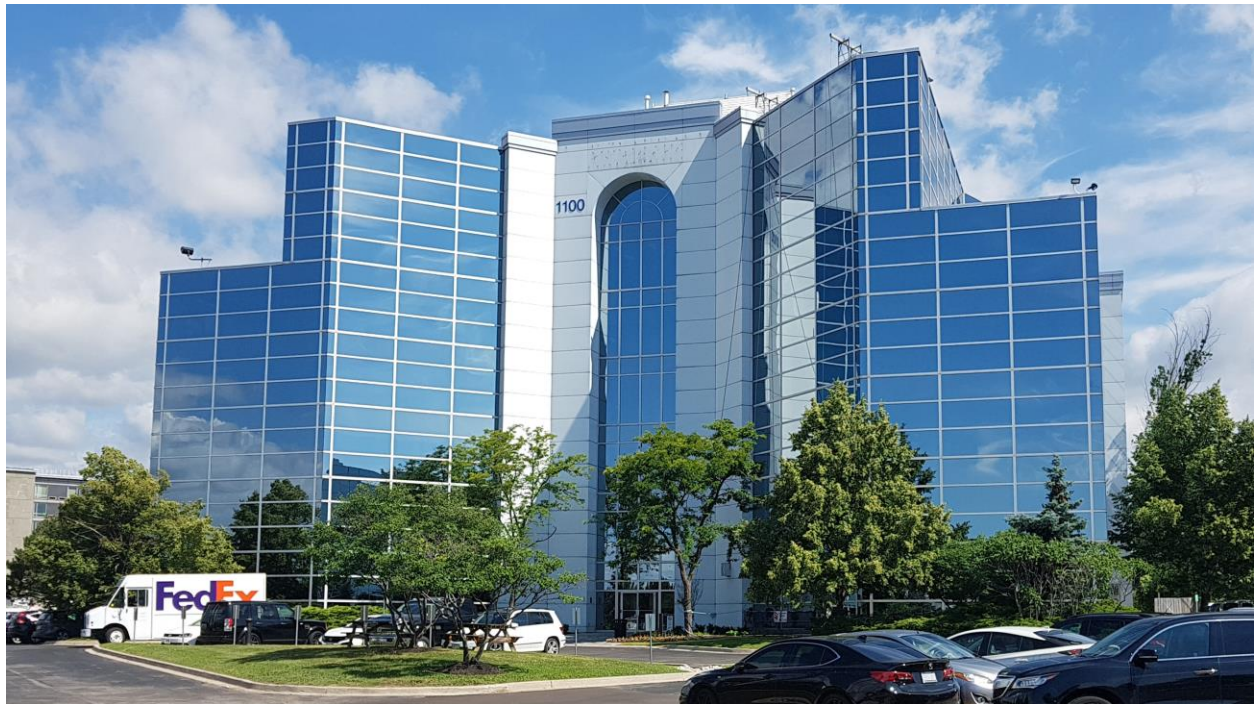
## 1100 Burloak Drive

Equally important, the new ECOGLASS/HM units are a perfect match. Take a look.
